FINAL REPORT OF NONFATAL COAL-MINE BUMP ACCIDENT

MINE NO. 10
WISCONSIN STEEL COAL MINES
INTERNATIONAL HARVESTER COMPANY
BENHAM, HARLAN COUNTY, KENTUCKY

August 19, 1967

J. L. Gilley Mining Health and Safety Engineer

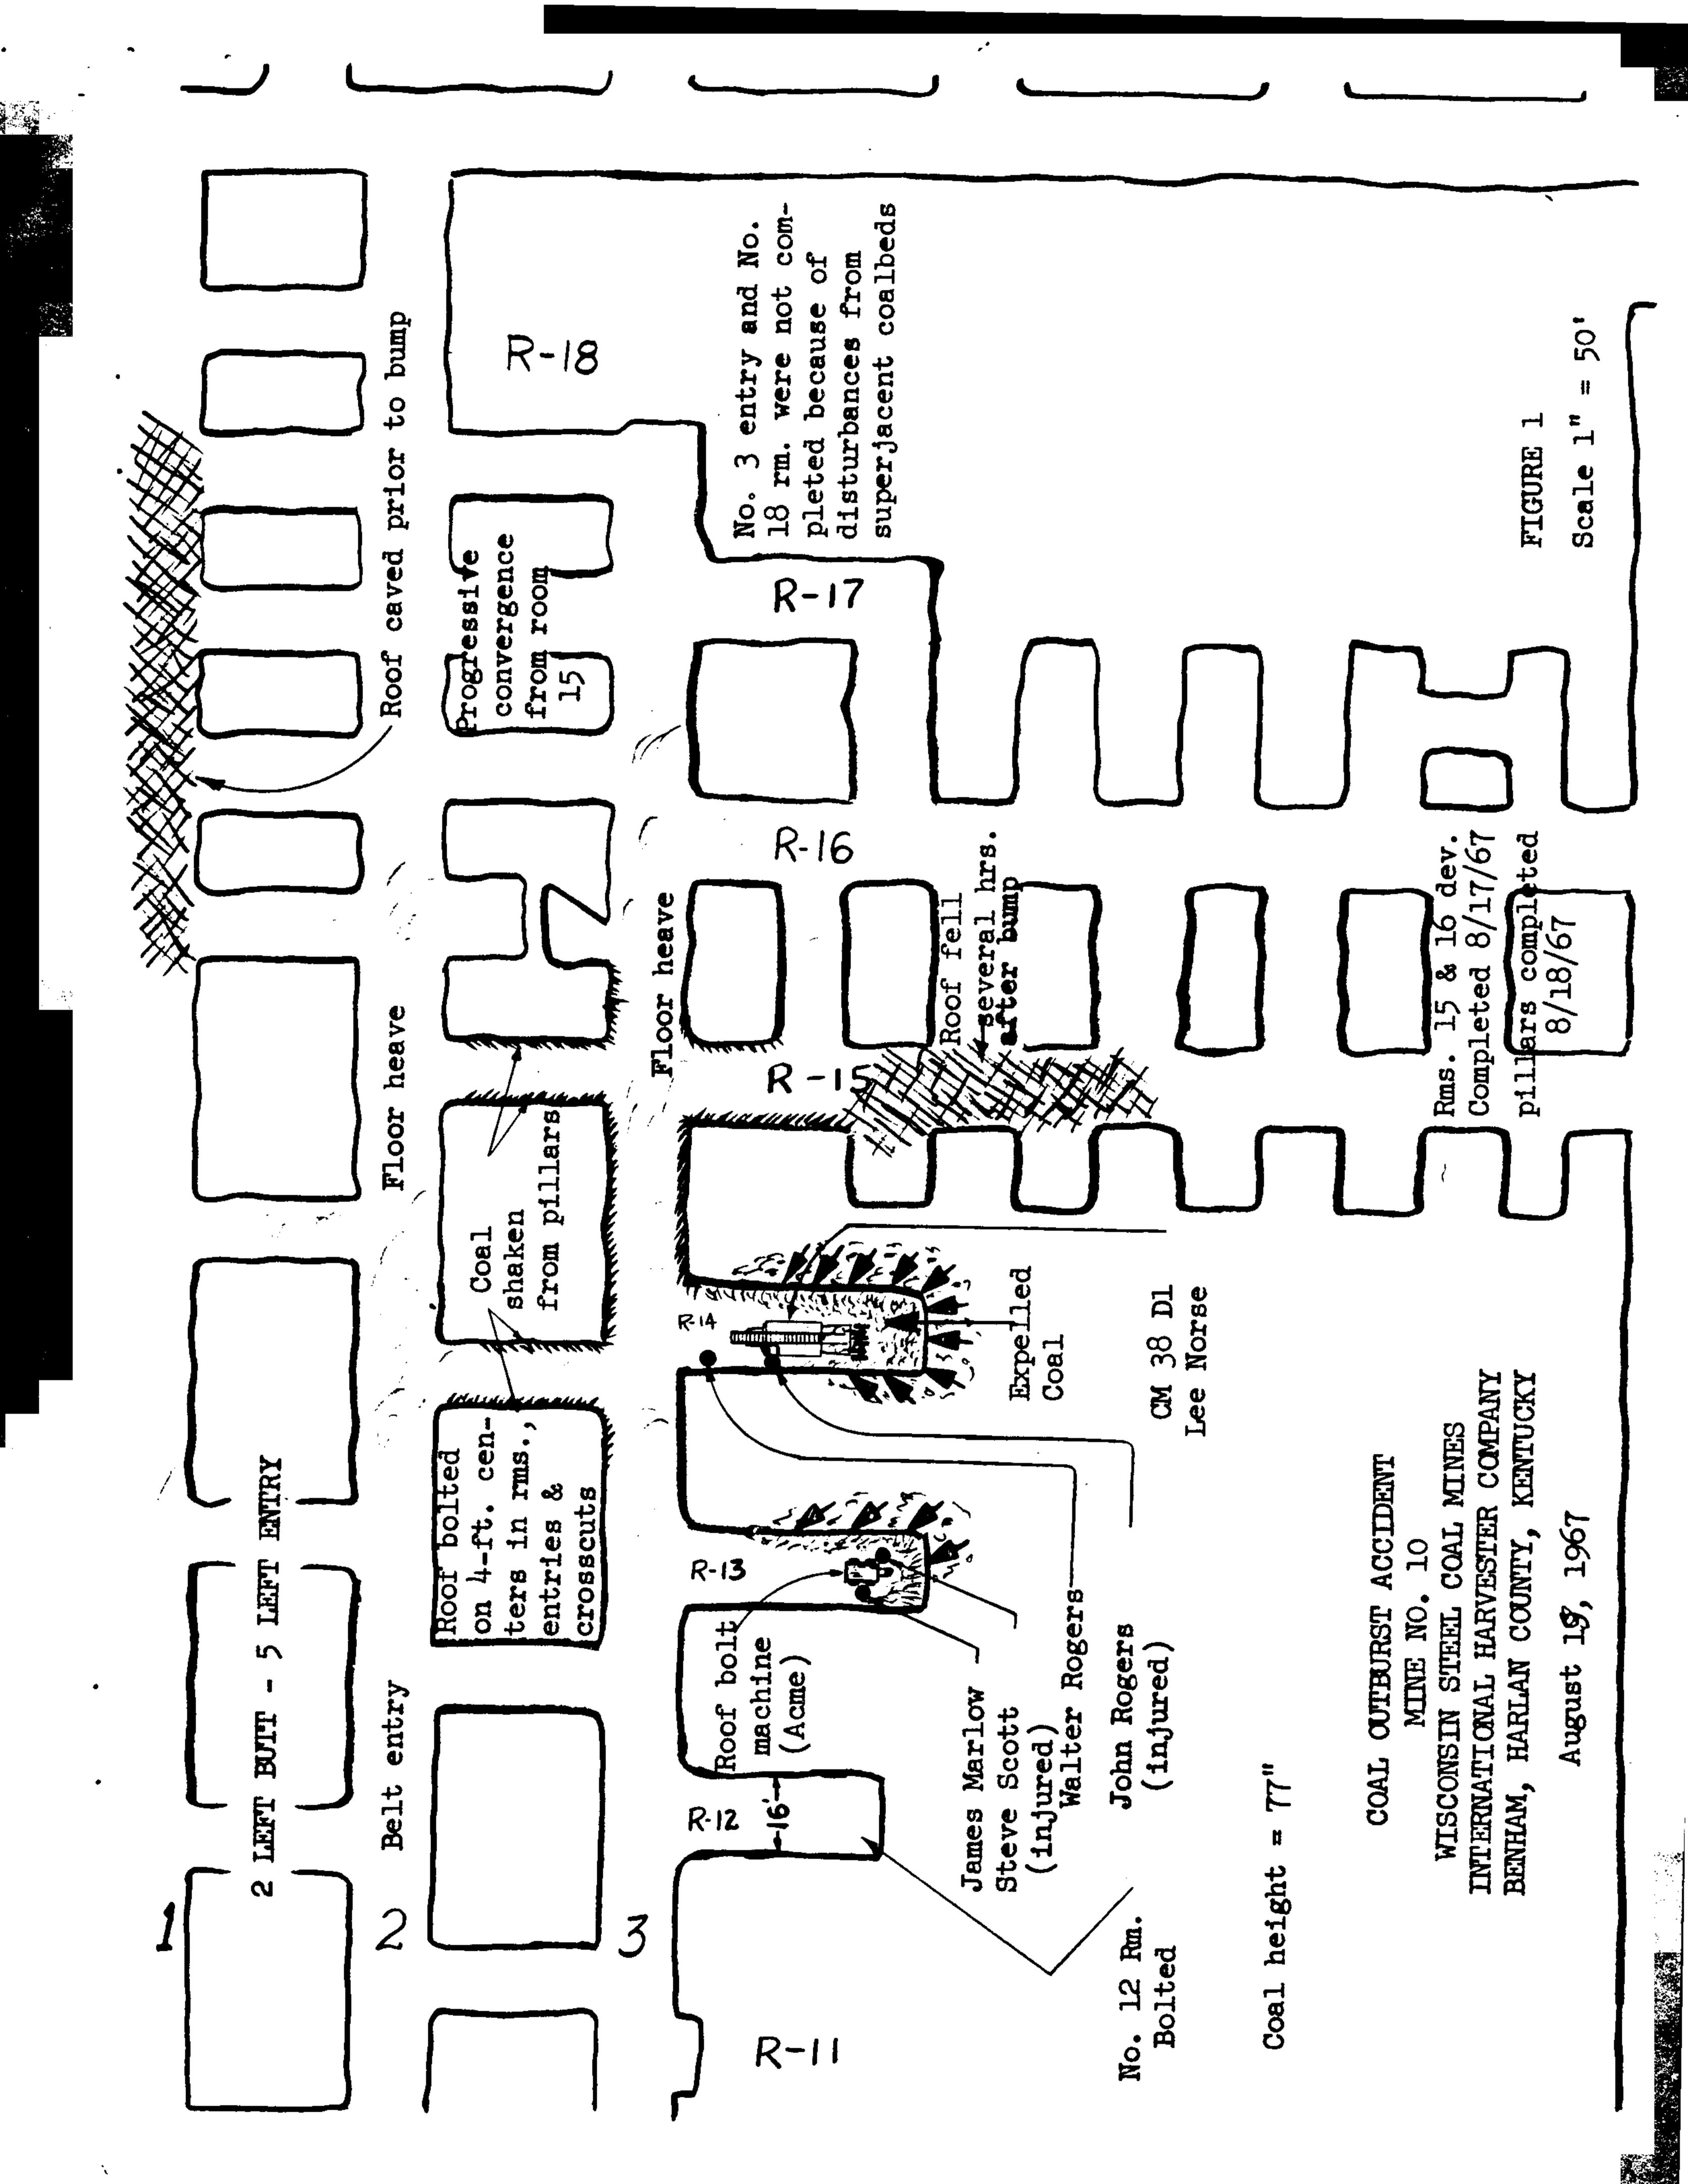
Weight was manifested in parts of the 2 left butt section, as indicated by sloughing of coal from the pillars, spalling and fracturing of the roof and heaving of the floor. From Figure 3, it will be noted that the Nos. 1 and 2 entries of 2 left butt terminated under a partially mined panel in the "B" coalbed and that the No. 3 entry of this group terminated directly under an undeveloped portion of the panel. Also, from Figure 3, it will be noted that the 2 left butt entry projections passed under areas in the "C" coalbed, that included first, a pillared area, then two protective coal barriers, each 230 feet thick, one on either side of a group of 3 entries, thence terminated under a pillared area.
